2011 Operations, Maintenance, and Monitoring Report

Marsh Island Hydrologic Restoration

State Project Number T/V-14
Priority Project List 6

August 2011
Iberia Parish

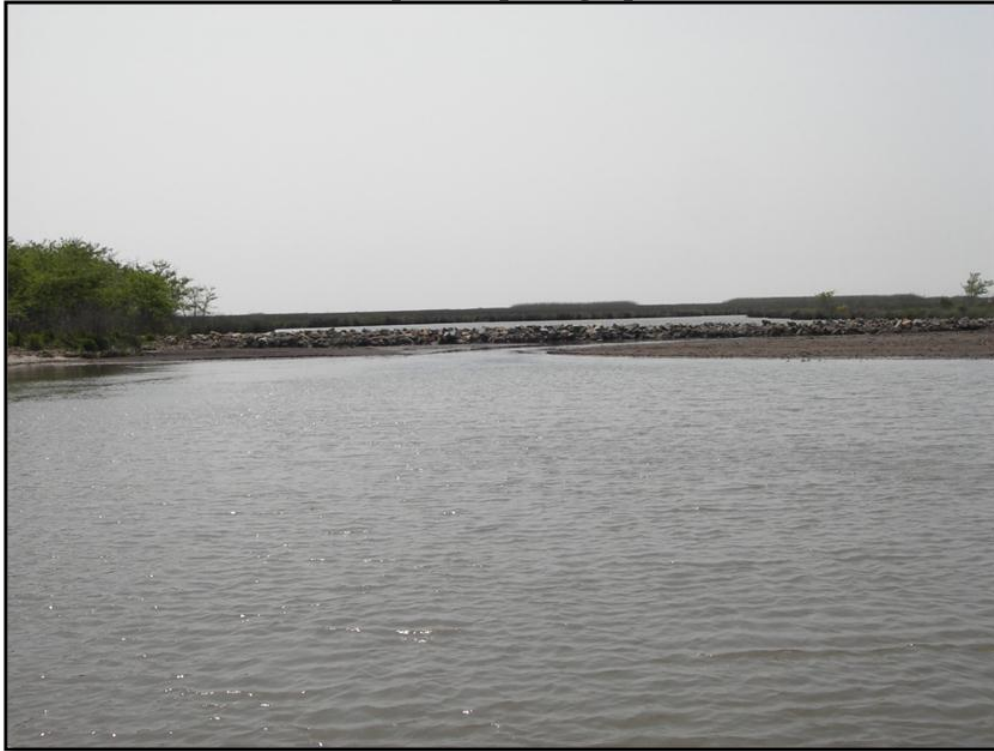
The erosion problems and Hurricane Rita damages have been repaired through the recent maintenance project that was completed in February 2009. The dike was capped and bank paving installed on both ends of the closure. This site is in good condition since this work was performed. This site is showing significant silt deposition on the north side of the dike on both the east and west sides, with the majority of the silt appearing on the west side of the dike continuing along the shoreline for several hundred feet. (Photos: Appendix A, Photo 1).

Photo No.1, Closure No.1, view showing silt build-up on East and West side of closure

Item	Condition	Physical Damage	Corrosion	Photo #	Observations and Remarks
Steel Bulkhead / Caps	N/A				
Steel Grating	N/A				
Stop Logs	N/A				
Hardware	N/A				
Timber Piles	N/A				
Timber Wales	N/A				
Galv. Pile Caps	N/A				
Cables	N/A				
Signage / Supports	N/A				
Rip Rap (fill)	Good			1	Looks Good. Good silt deposition occurring on east and west side of closure.
Earthen Embankment	N/A

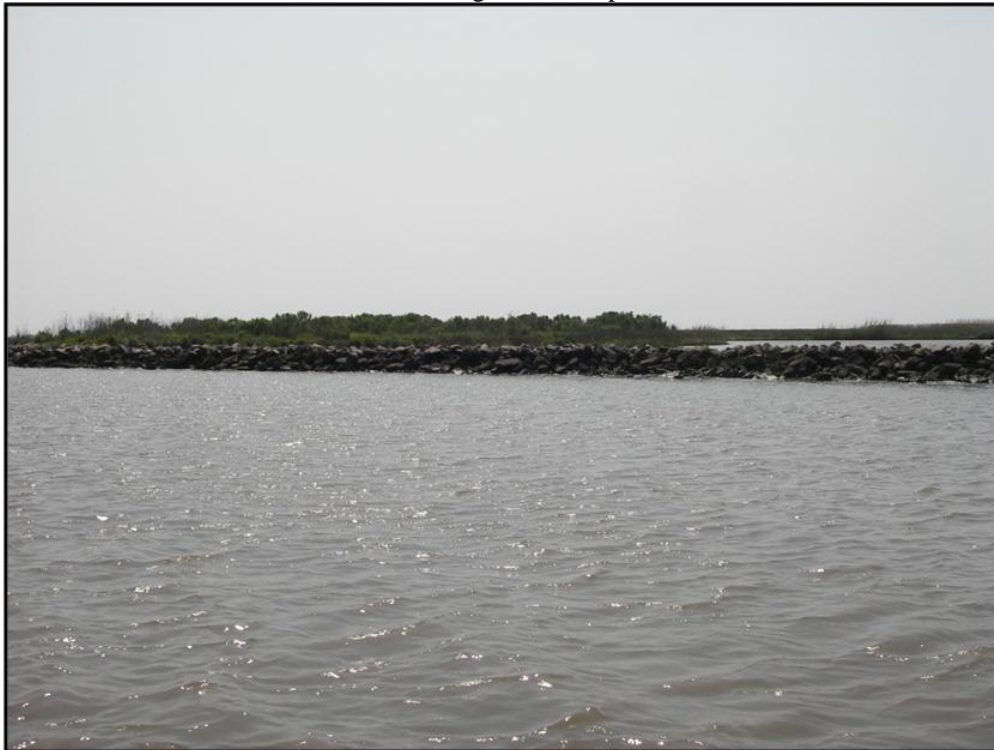
Photo No. 2, Closure No. 2

The dike was capped and bank paving installed as noted above and is in good condition since the work was performed. (Photos: Appendix A, Photo 2).

Item	Condition	Physical Damage	Corrosion	Photo #	Observations and Remarks
Steel Bulkhead / Caps	N/A				
Steel Grating	N/A				
Stop Logs	N/A				
Hardware	N/A				
Timber Piles	N/A				
Timber Wales	N/A				
Galv. Pile Caps	N/A				
Cables	N/A				
Signage / Supports	N/A				
Rip Rap (fill)	Good			2	Looks good
Earthen Embankment	N/A

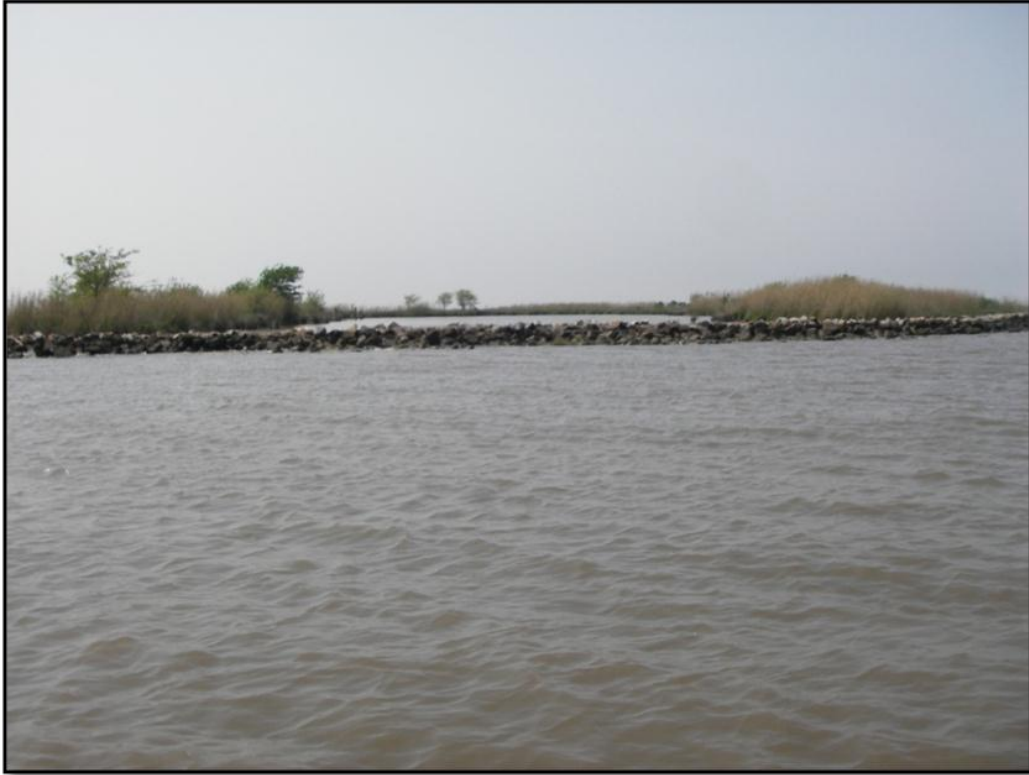
Photo No. 3, Closure No. 3

The rock closure dike appears in good condition and was extended on the western end along with installing bank paving during the recent maintenance event. Also, it was observed (and confirmed with aerial photography post Hurricane Rita) that a large open water area has developed within the marsh near the western terminus of Closure No. 3 and that the bankline between that point and the eastern end of Closure No. 2 has eroded very severely and such that the “landbridge” between Vermilion Bay on the north of Marsh Island and the northwestern portion of Lake Sand proper is now narrow and may become subject to breaching thus allowing an undesirable water connection between the two bodies of water. OCPR and COE agree that this area is in poor condition and should be considered for maintenance at some point in time. It is recommended that an additional reach of shoreline protection dike be constructed, an estimated 1,500 to 1,800 linear feet, to connect the western end of Closure No. 3 to the eastern end of Closure No. 2. This reach of bank has been recently surveyed and the estimated cost for rock dike and flotation is approximately \$800,000. OCPR and COE agreed that due to this area being of concern but not yet critical status; and budget constraints, this maintenance work would be undertaken at a later time. (Photos: Appendix A, Photo 3).

Item	Condition	Physical Damage	Corrosion	Photo #	Observations and Remarks
Steel Bulkhead / Caps	N/A				
Steel Grating	N/A				
Stop Logs	N/A				
Hardware	N/A				
Timber Piles	N/A				
Timber Wales	N/A				
Galv. Pile Caps	N/A				
Cables	N/A				
Signage / Supports	N/A				
Rip Rap (fill)	Good			3	Looks good
Earthen Embankment	N/A

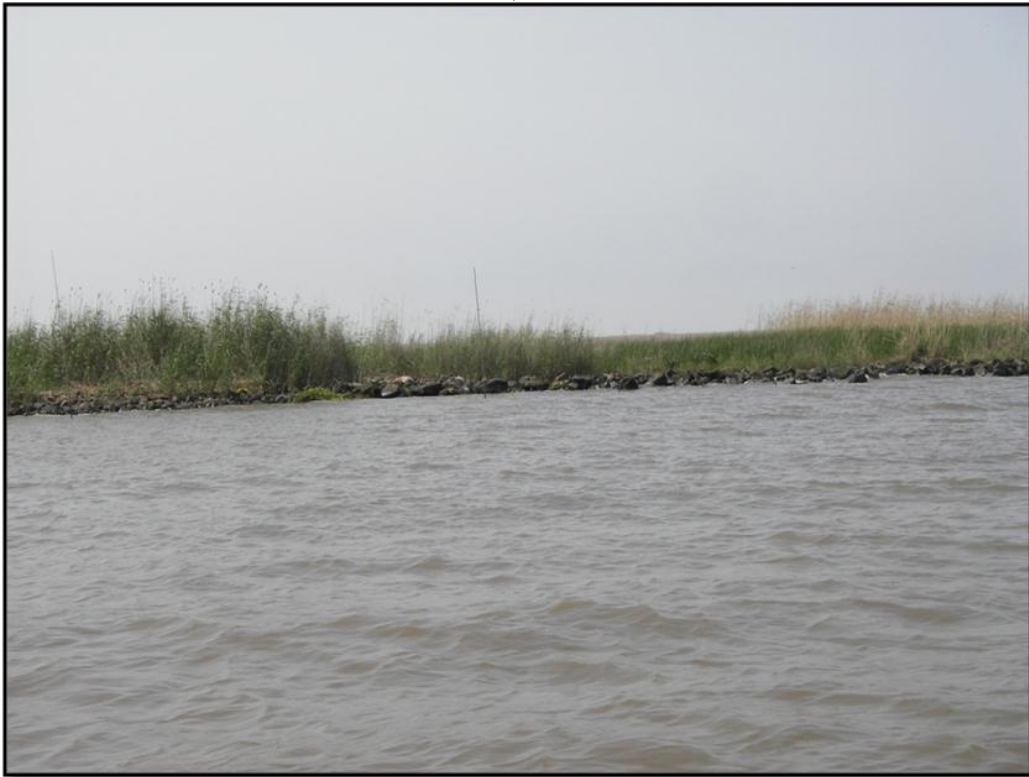
The Lake Sand Dike closure as originally constructed and recently repaired for Hurricane Rita damages, appears in good condition. The dike was capped in those areas where it was below elevation +3.0 as well as extended on the eastern end with bank paving. Dike has maintained elevation in capped areas. (Photos: Appendix A, Photos 4-5).

Photo No. 4, Closure No. 4 bank paving east side

Item	Condition	Physical Damage	Corrosion	Photo #	Observations and Remarks
Steel Bulkhead / Caps	N/A				
Steel Grating	N/A				
Stop Logs	N/A				
Hardware	N/A				
Timber Piles	N/A				
Timber Wales	N/A				
Galv. Pile Caps	N/A				
Cables	N/A				
Signage / Supports	N/A				
Rip Rap (fill)	Good			4, 5	Lake Sand looks good. The rock cap is holding well.
Earthen Embankment	N/A

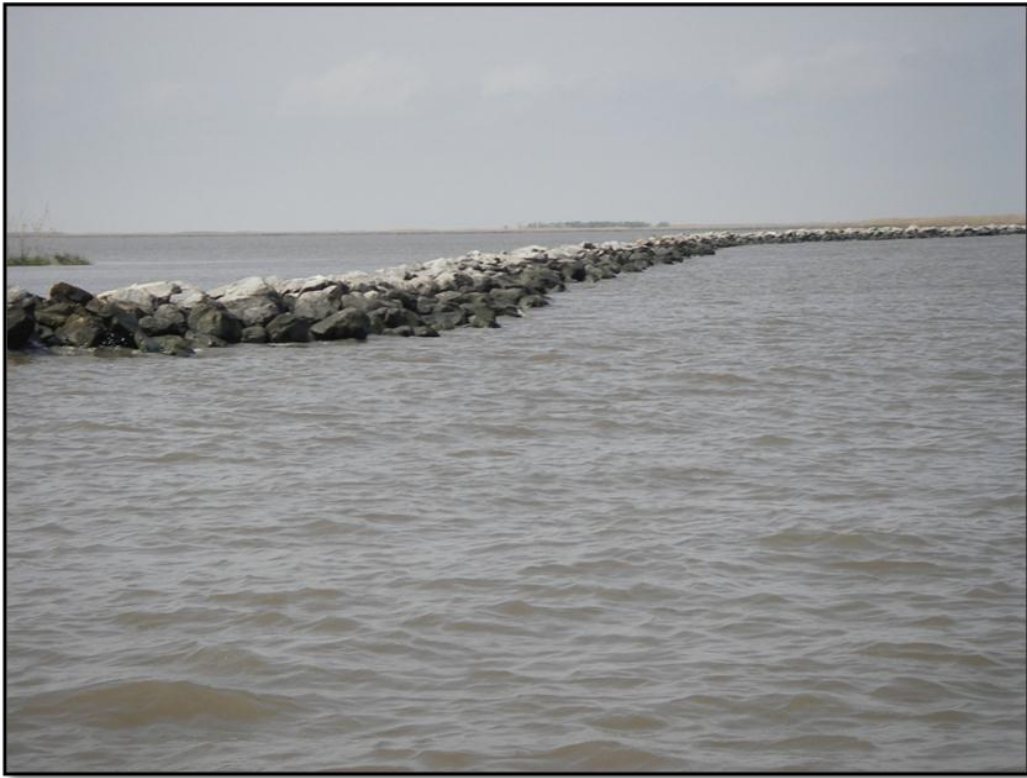
Photo No. 5, Closure No. 4 looking west

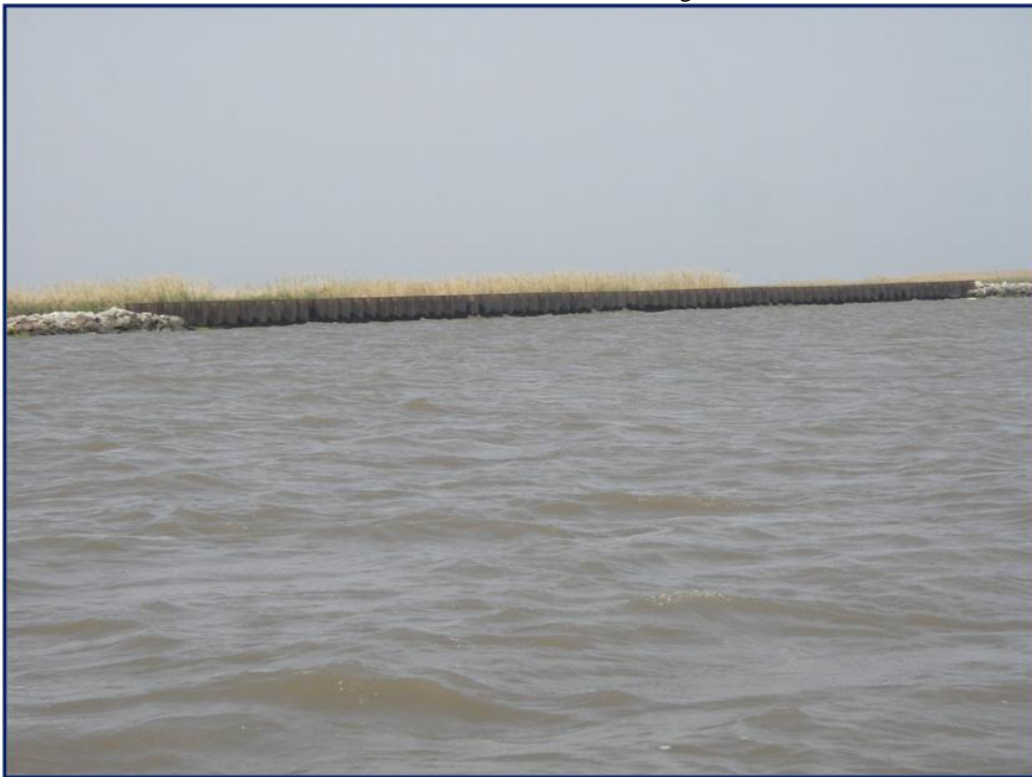
Photo No. 6, Closure No. 5

The steel sheet pile, rock riprap wingwalls, and stone bank/marsh paving placed as part of the Hurricane LILI repair project is in good condition and were apparently very effective in preventing additional damage by the erosive action of Hurricane Rita. The staff gage was re-set as part of the recent maintenance event. The overbank marsh areas paved to make same “hard” and paid for with O & M funding needs to be continually evaluated for its effectiveness. Overbank areas are presently sound and in great condition. (Photos: Appendix A, Photo 6).

Item	Condition	Physical Damage	Corrosion	Photo #	Observations and Remarks
Steel Bulkhead / Caps	Good			6	
Steel Grating	N/A				
Stop Logs	N/A				
Hardware	N/A				
Timber Piles	N/A				
Timber Wales	N/A				
Galv. Pile Caps	N/A				
Cables	N/A				
Signage / Supports	N/A				
Rip Rap (fill)	Good			6	Looks good. No change since previous inspection. Bank paving is holding up well.
Earthen Embankment	N/A

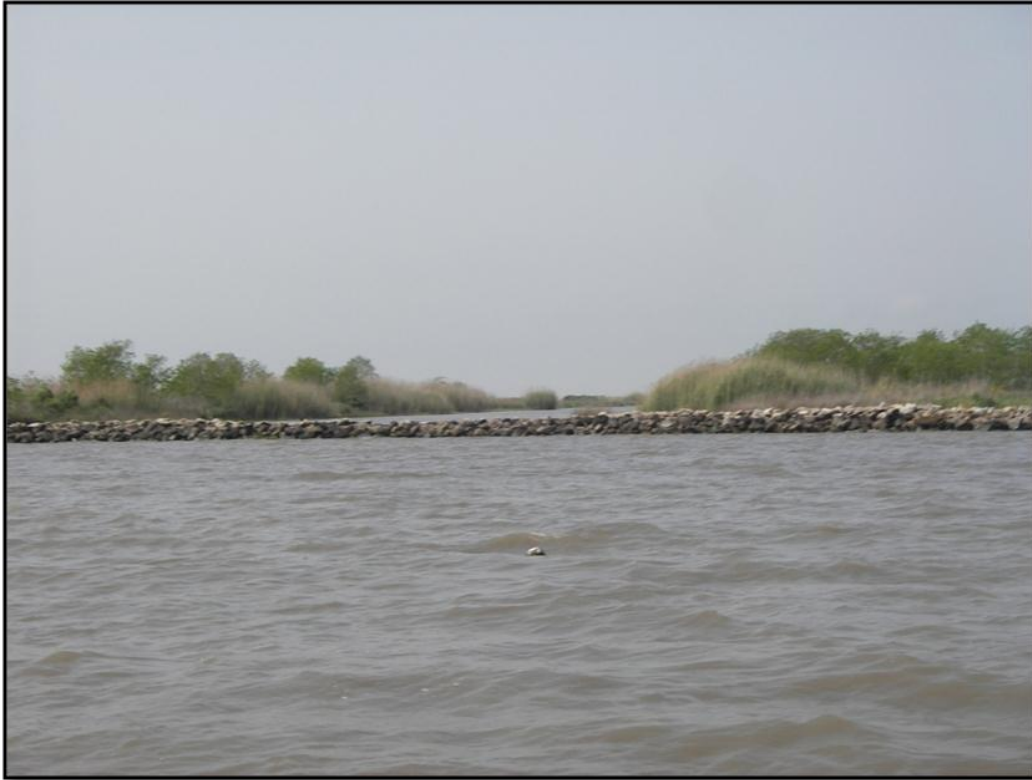
Photo No. 7, Closure No. 6

The breach on the southern end of the dike that had occurred prior to Hurricane Rita and subsequently worsened as a result of the tidal surge has been repaired as part of the recent maintenance event. The dike was extended on the northern end and bank paving was installed on both ends of the closure. This site is in good condition since the repairs have been made. (Photos: Appendix A, Photo 7).

Item	Condition	Physical Damage	Corrosion	Photo #	Observations and Remarks
Steel Bulkhead / Caps	N/A				
Steel Grating	N/A				
Stop Logs	N/A				
Hardware	N/A				
Timber Piles	N/A				
Timber Wales	N/A				
Galv. Pile Caps	N/A				
Cables	N/A				
Signage / Supports	N/A				
Rip Rap (fill)	Good			7	Looks good. No change from previous inspection.
Earthen Embankment	N/A

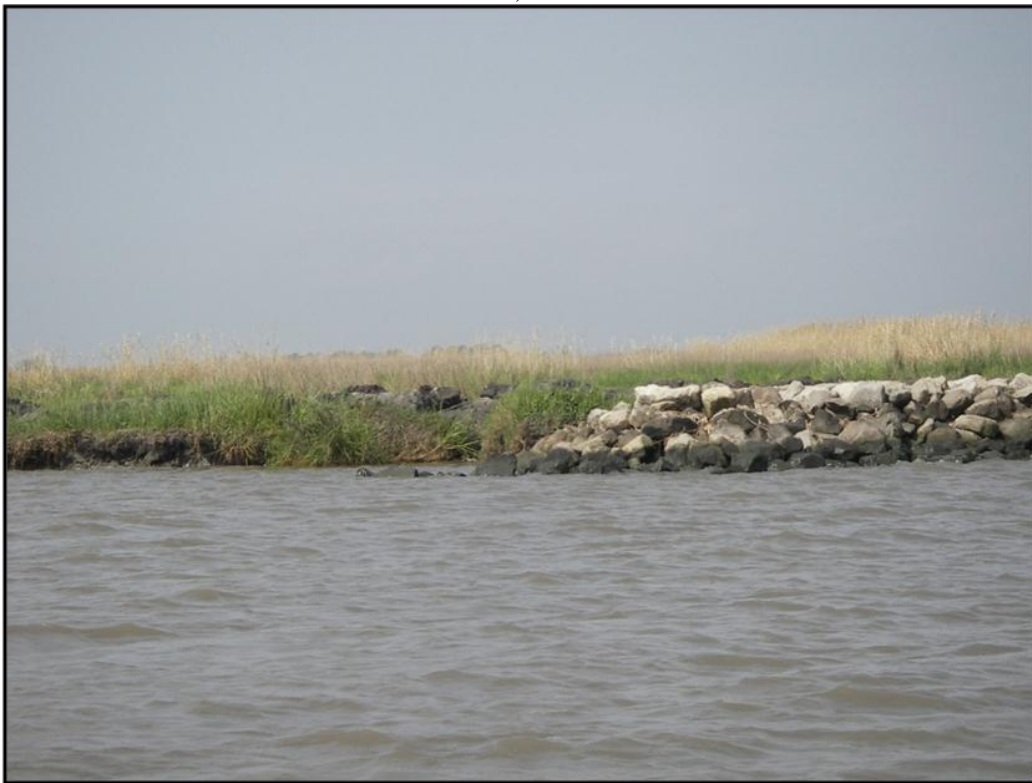
This closure site is in good condition and spoil material from the dredging of the north-south canal in 2008 was placed along the eastern end of the rock dike in an effort to stabilize this section of shore. In addition dredge spoil material was pumped behind the rock dike as part of this same access dredging and a small area of marsh creation was formed which is now starting to vegetate. (Photos: Appendix A, Photos 8-9).

Photo No. 8, Structure No. 7 East side of rock dike

Item	Condition	Physical Damage	Corrosion	Photo #	Observations and Remarks
Steel Bulkhead / Caps	N/A				
Steel Grating	N/A				
Stop Logs	N/A				
Hardware	N/A				
Timber Piles	N/A				
Timber Wales	N/A				
Galv. Pile Caps	N/A				
Cables	N/A				
Signage / Supports	N/A				
Rip Rap (fill)	Good			8, 9	Looks good. Grass establishing nicely in the two (2) marsh creation cells just east of the plug.
Earthen Embankment	N/A

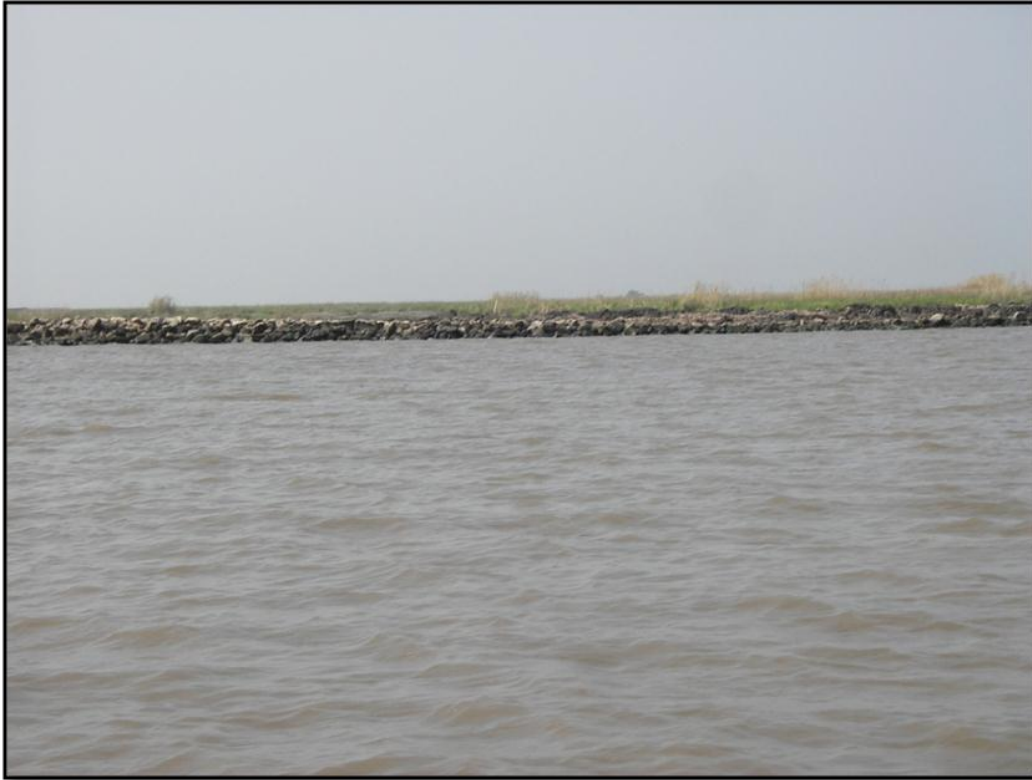
Photo No. 9, Structure No. 7, marsh creation behind rock dike starting to vegetate

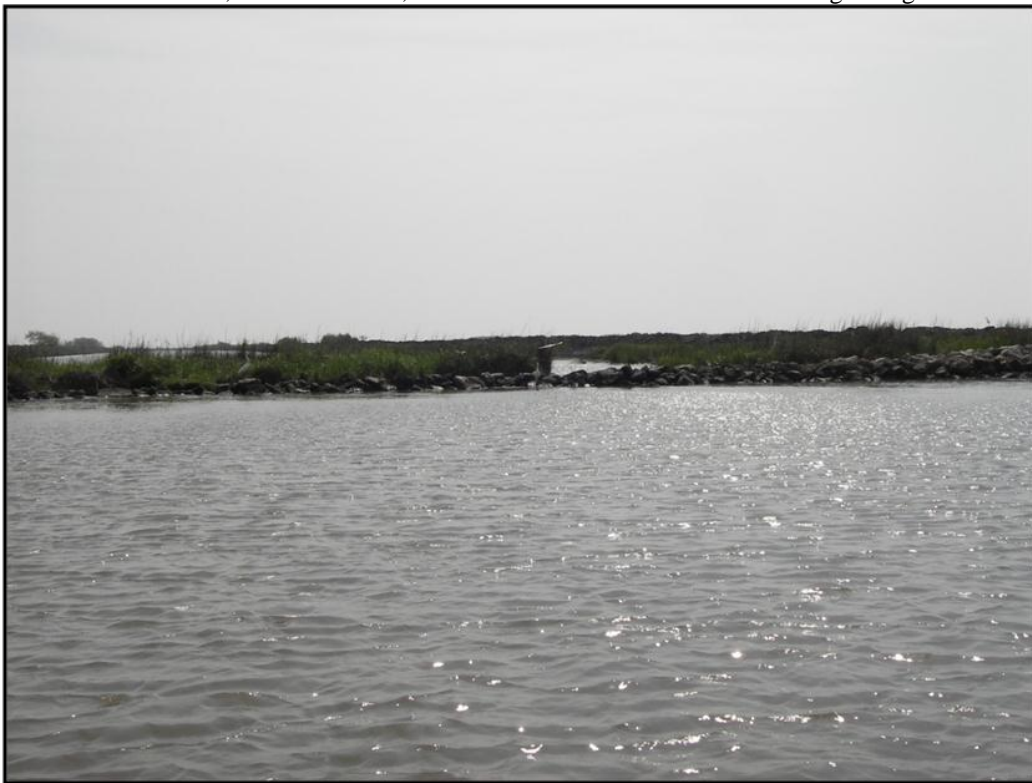
This closure site is in good condition since the existing breach on the south side of the closure was repaired in the 2008 maintenance event noted above in Section IV. Spoil material was placed to close off the breach and also placed on top of the existing rock dike. Spoil material was also placed from the north end of the rock dike towards the bay to make a connection to the existing mitigation rock dike along the bay shore. (Photos: Appendix A, Photos 10).

Photo No. 10, Closure No. 8, marsh creation behind rock dike starting to vegetate

Item	Condition	Physical Damage	Corrosion	Photo #	Observations and Remarks
Steel Bulkhead / Caps	N/A				
Steel Grating	N/A				
Stop Logs	N/A				
Hardware	N/A				
Timber Piles	N/A				
Timber Wales	N/A				
Galv. Pile Caps	N/A				
Cables	N/A				
Signage / Supports	N/A				
Rip Rap (fill)	Good			10	Looks good. Grass establishing nicely in the two (2) marsh creation cells.
Earthen Embankment	N/A

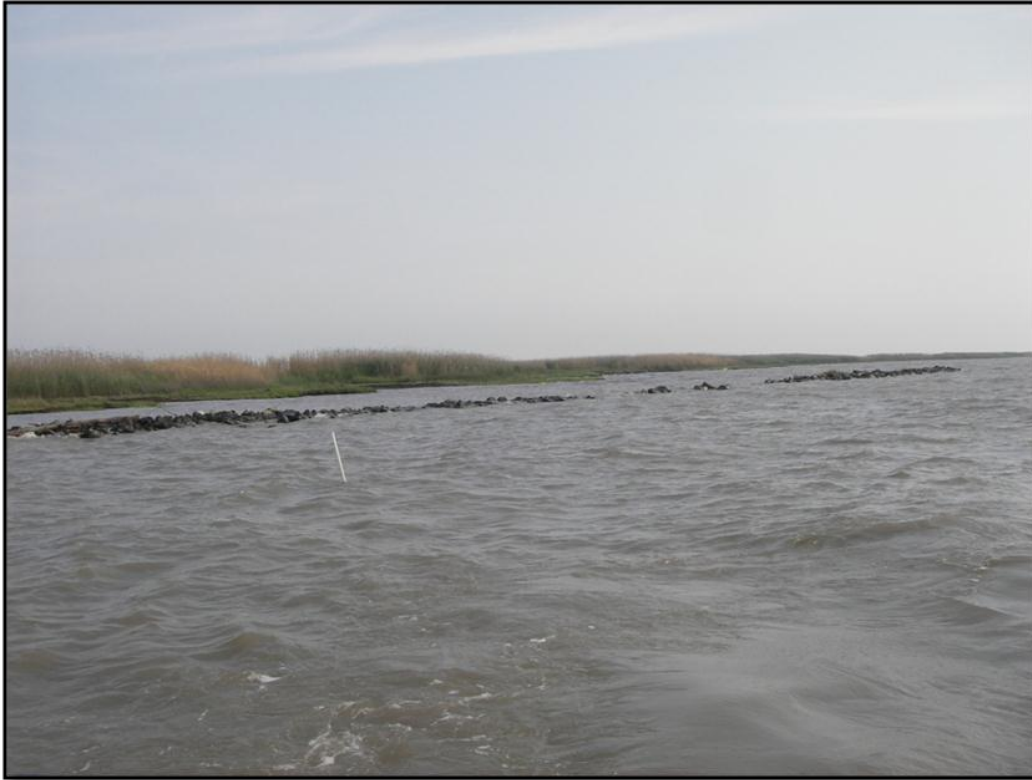
The rock riprap shoreline protection dike constructed on the south shoreline of Marsh Island was noted to now sit out further into the waters of the Gulf as discussed in the last inspection. Conditions were such that the feature was functioning well and that sediment had accreted and a growth of marsh vegetation had extended over the new fill. This rock shoreline feature will still function as a breakwater and extend the life of the earthen pipeline closure to the north. The recent construction of the TV-21 East Marsh Island Marsh Creation project has helped to reinforce the breach that had occurred on the southeast corner of the pipeline canal since the last inspection. The pipeline canal north of the rock breakwater was filled in with sediment from the marsh creation project and construction of containment dikes have now closed off the breach at the shoreline. No maintenance will be necessary at closure No. 9 as a result of the work performed through the TV-21 project. (Photos: Appendix A, Photos 11-13).

Photo No. 11, Structure No. 9 rock dike, view showing some settlement of rock dike

Item	Condition	Physical Damage	Corrosion	Photo #	Observations and Remarks
Steel Bulkhead / Caps	N/A				
Steel Grating	N/A				
Stop Logs	N/A				
Hardware	N/A				
Timber Piles	N/A				
Timber Wales	N/A				
Galv. Pile Caps	N/A				
Cables	N/A				
Signage / Supports	N/A				
Rip Rap (fill)	Fair			11, 12	Dike is settling in some areas. Breach is closed and shoreline looks good since the TV-21 project.
Earthen Embankment	N/A

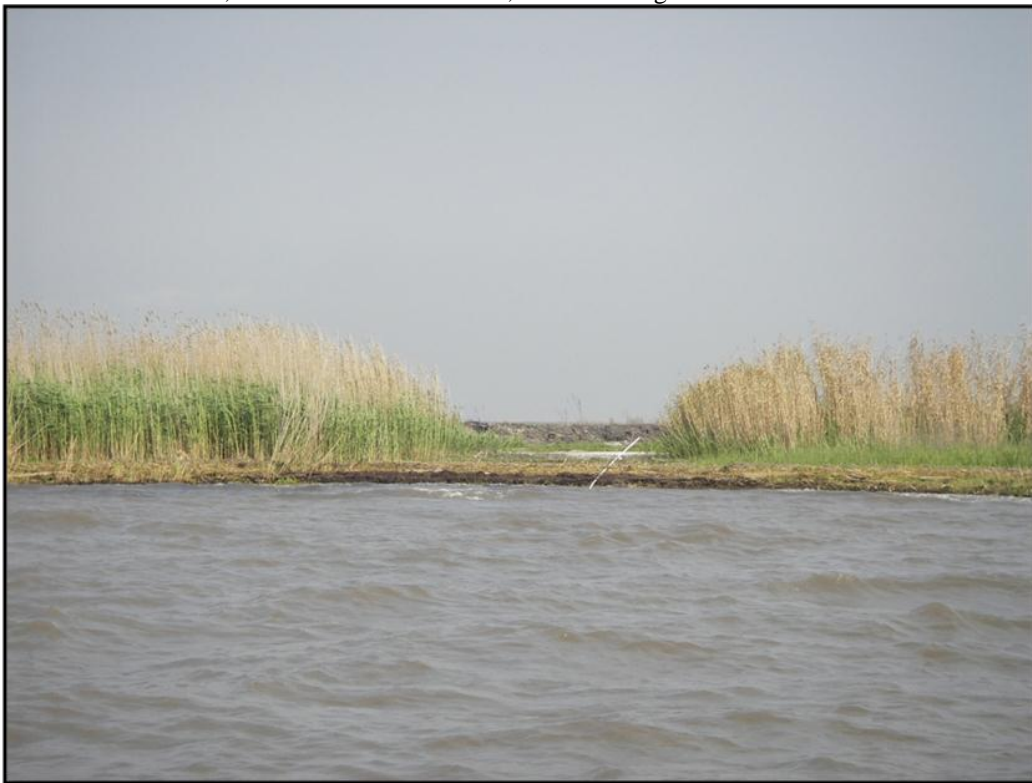
Photo No. 12, Structure No. 9, view showing canal plugged and vegetation developing

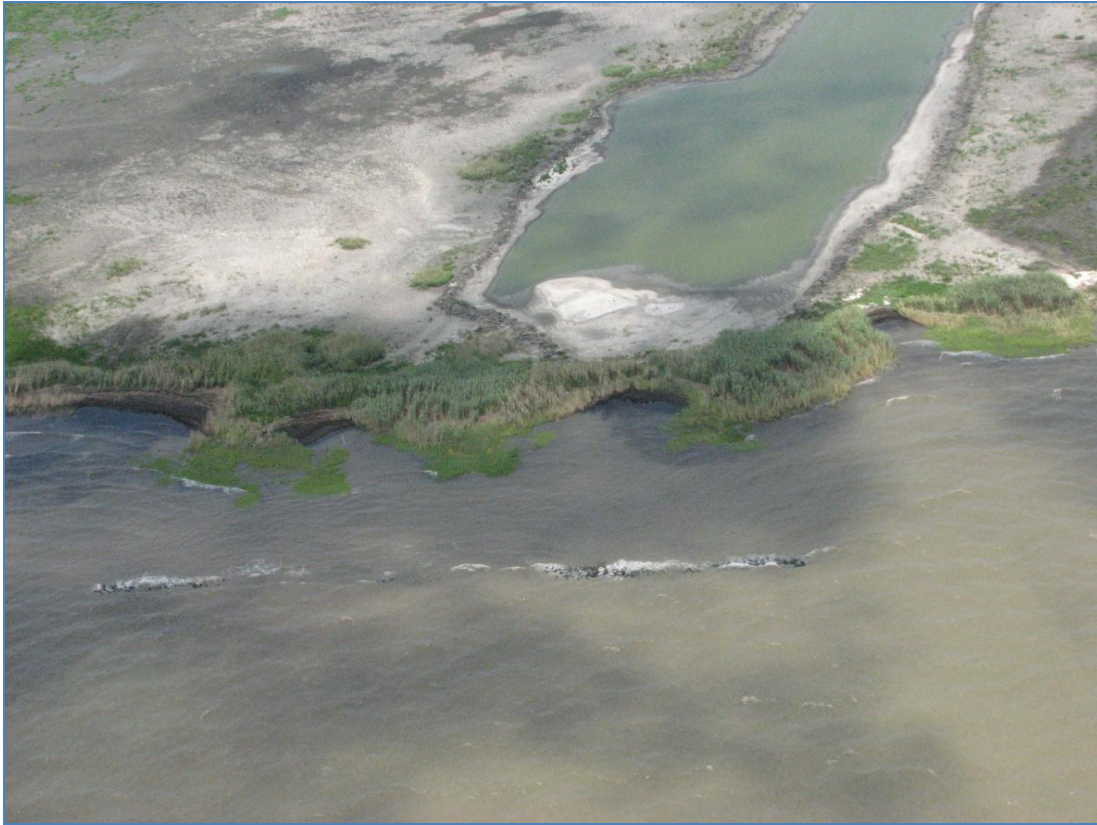
Photo No. 13, Aerial view of Structure No. 9 and plugged pipeline canal
